OCE AFTERMARKET CARTRIDGE AND CHIP REPORT 2008-01-29

FUTURE TECHNOLOGIES PLANS TO OFFER
A SOLUTION TO THE PROBLEMS THAT
HAVE BEEN ENCOUNTERED DURING THE
TESTING PHASE OF THE OCE INK
REMANUFACTURING PROJECT TAKING
PLACE AT CRAFTSIGNS.

FINDINGS AND IMPLEMENTATION

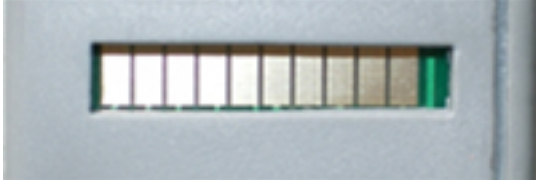
</div> <p style="text-align: center;">This is an image of how an original Océ cartridge and chip align in the window of the cartridge, you will notice that there is an equal space of green on each side of the chip and that the bottom of the chips contact points run parallel to the bottom of the cartridge window</p>
<p style="text-align: center;">Figure 2</p>	<div style="text-align: center;">

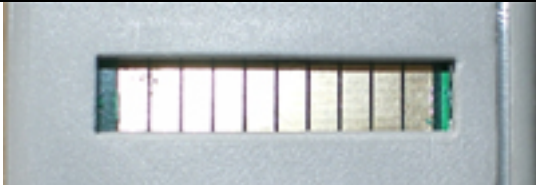
<p style="text-align: center;">Figure 3</p>	<div style="text-align: center;">

</div> <p style="text-align: center;">This is an image of how an FT chip sits if inserted into a Signtronic cartridge, as you can see the alignment is out on either end and the chip is not running 100% parallel with the base of the window. The reason why we encounter this is due to the cartridge. When the cartridge was manufactured it was not exactly manufactured to that of the OEM specification and thus the chip sit to far down the window causing the chip to align incorrectly. The solution is simple and is visible in the next row.</p>

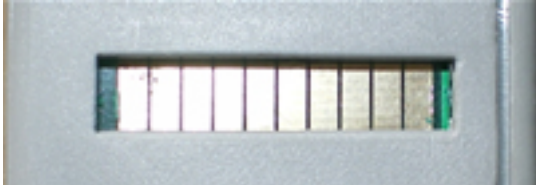
</div> <p style="text-align: center;">This image contains the same chip and cartridge as the above image, the only difference is that the chip has been aligned correctly in the cartridge thus eliminating the error 3. The persons that will be installing the chip need to be aware of this and make adjustment to align the chip as seen in the above image.</p>
<p style="text-align: center;">Figure 4</p>	<div style="text-align: center;">

</div> <p style="text-align: center;">Future Technologies would like to make it known that we have found certain Signtronic cartridge that are faulty and cause the chip to misalign even if the chip looks 100% aligned as in figure 4. Therefore if you encounter an error 3 and the alignment of the chip is perfect according to the above image then the only solution to the problem is to discard that cartridge and replace it with a new one.</p>

- **PHASE 1** – INSERT THE CHIP INTO THE CARTRIDGE AS PER THE VISUAL REFERENCE GUIDE PROVIDED ON PAGE 4, FIGURE 4
- **PHASE 2** – INSERT THE CARTRIDGES INTO ALL THE TEST PRINTERS, IN COMPLETE SETS OR AS AN INDIVIDUAL COLOR (BLACK, CYAN, MAGENTA, YELLOW, LIGHTCYAN, AND LIGHT MAGENTA). THIS PROCESS IS WHERE THE ERROR WILL BE IDENTIFIED AND “FIXED” ACCORDING TO THE ERROR DISPLAYED. PLEASE USE THE ERROR REFERENCE GUIDE PROVIDED ABOVE TO SOLVE THE PROBLEM ENCOUNTERED DURING THIS PHASE.
- **PHASE 3** – IF THERE SHOULD BE A SHORTAGE OF CHIPS DUE TO ERRORS BEING IDENTIFIED, AND THEN CONTACT FUTURE TECHNOLOGIES AND THEY WILL PROVIDE A REPLACEMENT WITHIN 48 HOURS UPON RECEIVING THE REQUEST.
- **PHASE 4** – REDO PHASE 1 TO 3 UNTIL ALL CARTRIDGES ARE DISPLAYING “PRINT READY” ON THE DISPLAY PANEL OF THE PRINTER.
